## **ANALYSIS OF CORROSION INDUCED FAILURE OF OIL PIPELINE IN THE MARINE ENVIRONMENT AND POSSIBLE CONTROL MEASURES**

**S.A. AMADI**

Department of Chemical/Petrochemical Engineering,  
Rivers State University of Science and Technology  
Nkpolu-Oroworukwo, Port Harcourt

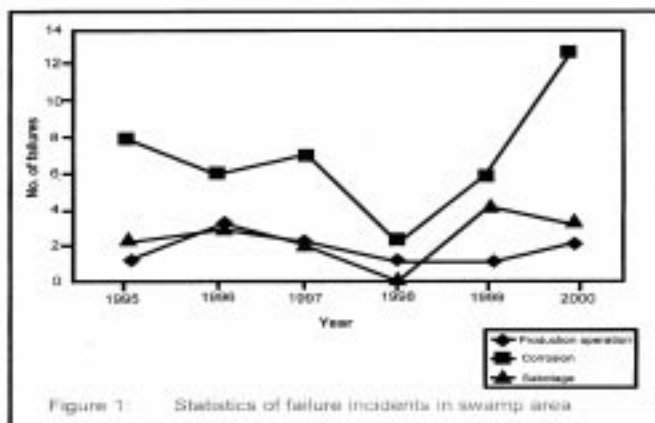
Figure 1: Statistics of failure incidents in swamp area

Figure 1 shows the statistical representation of failure that took place in the swamp area for the period under investigation. Similarly, Figure 2 represents corrosion induced failure that took place in the area of one of the oil companies operating in the Niger Delta Region.

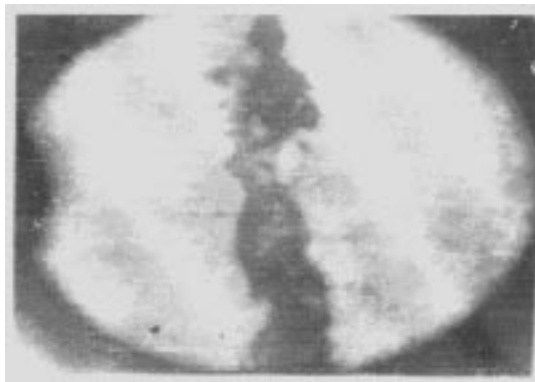
Figure 5 confirms that pitting corrosion was the cause of the patches and roughened surface of the pipeline. Figure 6 shows areas covered by scales, which have allowed corrosion activities to continue under it. Whereas, Figure 7 reveals visible cracks initiated by pits overlapping each other.

rough edges and patches of pits which may have been as a result of cracks emerging from the pits overlapping to produce a high stress concentration. Such cracks reduce the strength of the metal and it can be concluded that the failure occurred as a result of the following:

- (i) Wall thickness reduction from 12mm to between 1mm and 2mm
- (ii) Pits overlapping each other

**Fig. 7** An optical micrograph of a cross-section of sample E showing ruptured area
