ANALYSIS OF CORROSION INDUCED FAILURE OF OIL PIPELINE IN THE MARINE ENVIRONMENT AND POSSIBLE CONTROL MEASURES

S.A. AMADI

Department of Chemical/Petrochemical Engineering,
Rivers State University of Science and Technology
Nkpolu-Oroworukwo, Port Harcourt, Nigeria

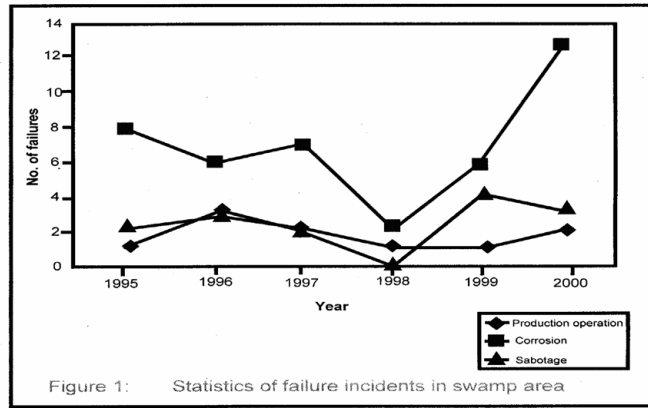
Figure 1: Statistics of failure incidents in swamp area

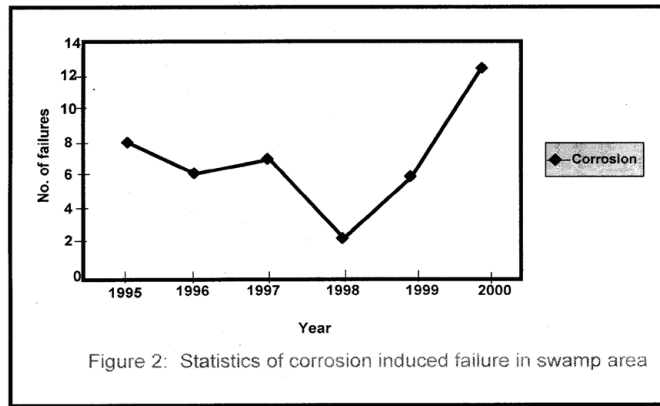
Figure 2: Statistics of corrosion induced failure in swamp area

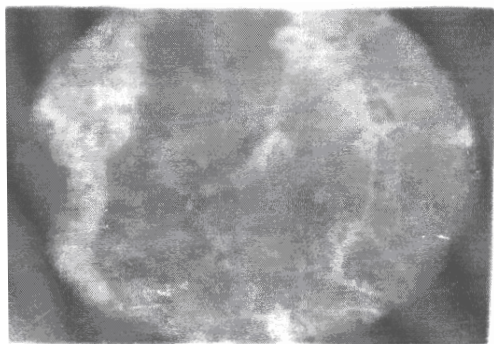
Figure 5 confirms that pitting corrosion was the cause of the patches and roughened surface of the pipeline. Figure 6 shows areas covered by scales, which have allowed corrosion activities to continue under it. Whereas, Figure 7 reveals visible cracks initiated by pits overlapping each other.

Accumulation of deposits, scale and corrosion products in the Pipeline could have promoted the pitting corrosion due to the formation of concentrated cell under the deposit/scale. Figure 6 shows tight scale deposit with corrosion activity going on beneath the scale resulting in highly localised corrosion and setting in of hydrogen embrittlement phenomenon. Figure 7 show signs of rough edges and patches of pits which may have been as a result of cracks emerging from the pits overlapping to produce a high stress concentration. Such cracks reduce the strength of the metal and it can be

Fig. 6 An optical micrograph of a cross-section of sample D showing a region where scales were scrapped off the pipe work

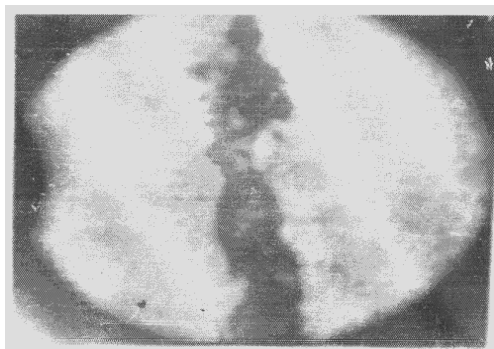
Fig. 7 An optical micrograph of a cross-section of sample E showing a ruptured area

stress concentration leading to reduction in wall thickness followed by rupture.
